EPA/600/R-98/129 September 1998

## **Evaluation of Convergent Spray Technology** Spray Process for Roof Coating Application

J. Scarpa, B. Creighton, T. Hall, K. Hamlin, T. Howard, M. Kelly,
Q. Lundy, and L. Thomson
Materials & Processes Department
United Space Boosters, Inc.
Huntsville, Alabama 35895

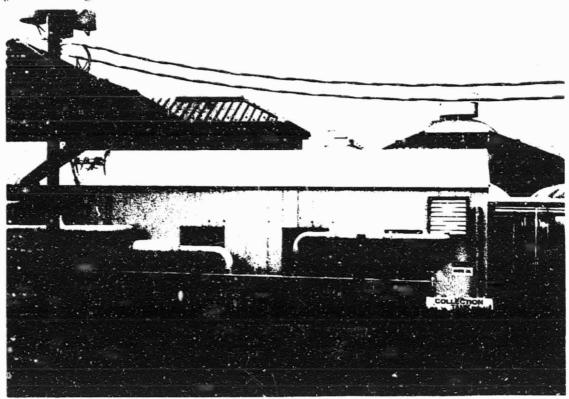
Photo 13. Building 4734—North Side with White Topcoat Applied
